Tank Leak – Fill Valve Hose Position

Tank Leakage from Hose Siphoning

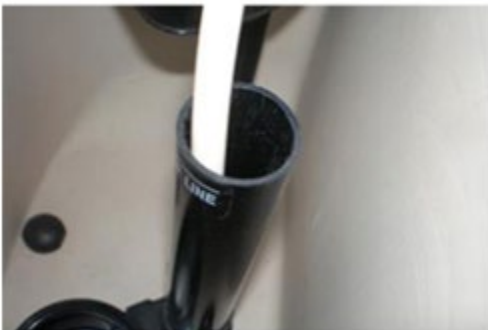
Incorrect (Unsecured Hose)

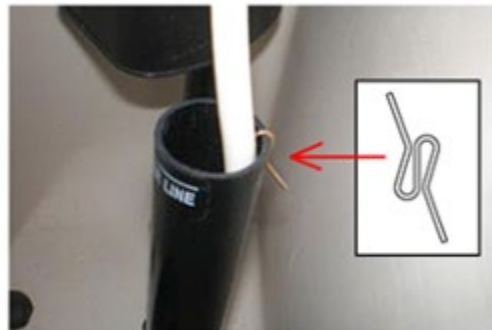
Correct (Hose Secured with Clip)

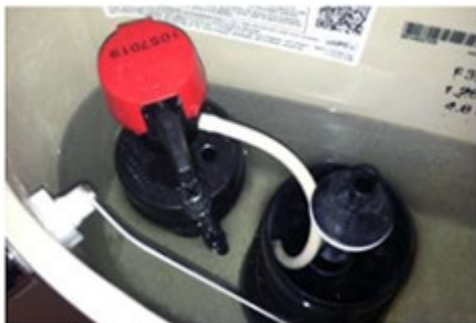
Incorrect (Detached Hose)

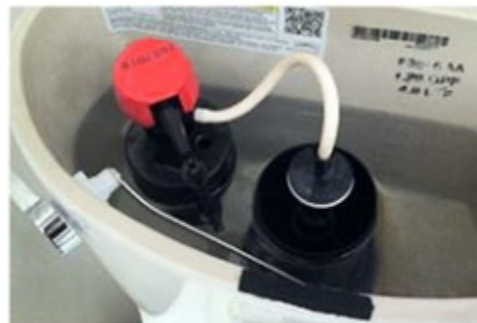
Correct (Hose Attached to Valve)
